Home Inspection

Grant
7142 21st Street
Omaha, NE 68048

Property Information

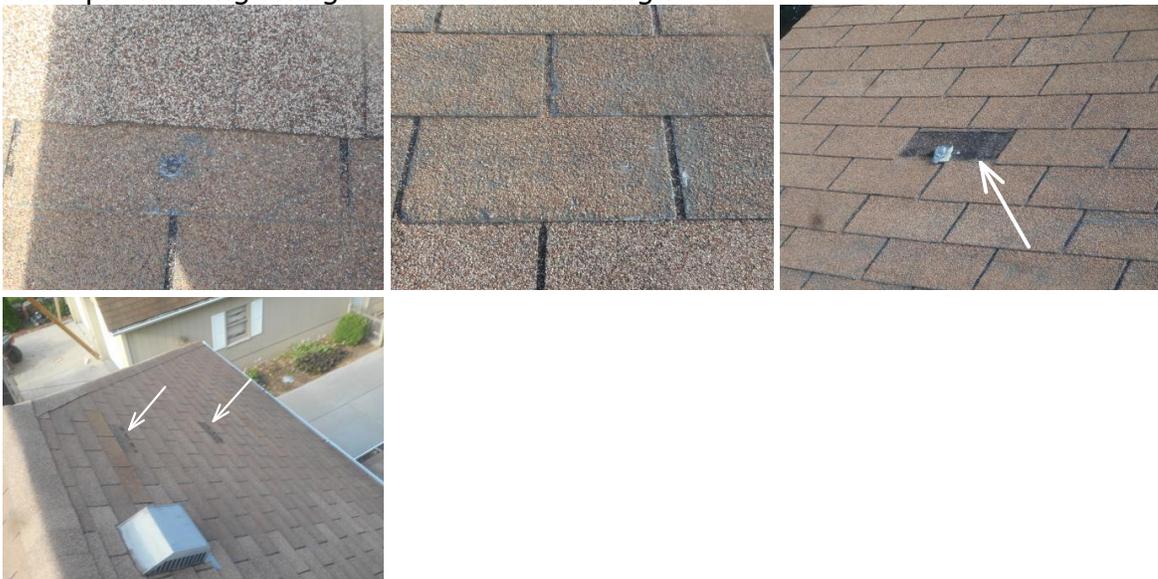
4. Roof Covering: 3 tab asphalt shingle: Shingles at south facing roof and lower south roof have significant granular loss. Some shingles in this area have been replaced. There is a missing shingle tab at south facing roof. A couple missing shingle tabs at west facing roof.

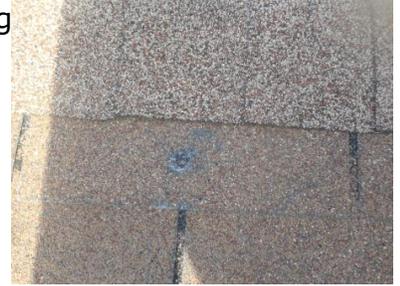
8. Roof Type: Gambrel
9. Approximate Age: 14 to 17 years
10. Roof Covering: 3 tab asphalt shingle: Shingles at south facing roof and lower south roof have significant granular loss. Some shingles in this area have been replaced.

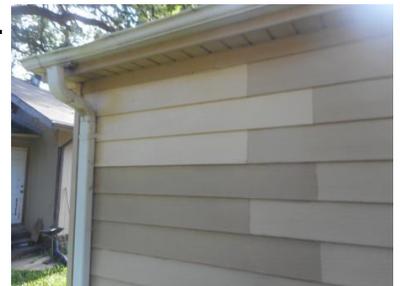
1. Siding: Metal: Some siding on back addition a different color.

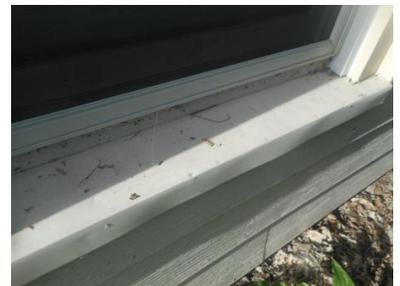
2. Trim: Metal clad
3. Soffit/Fascia: Metal clad
4. Entry Doors: Wood and metal
5. Windows: Metal clad : There is some denting from hail at metal cladding on north windows.

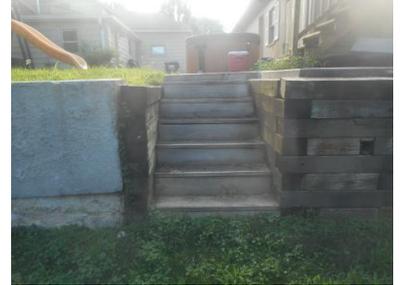
1. Driveway: Concrete
2. Walks: Concrete
3. Steps:
4. Porch / Stoop: Wood
5. Patio: Concrete: Patio has settlement cracking.
6. Railings: No handrail at steps at tie wall.

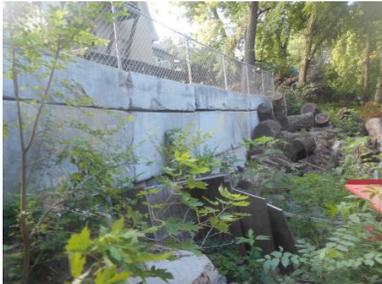
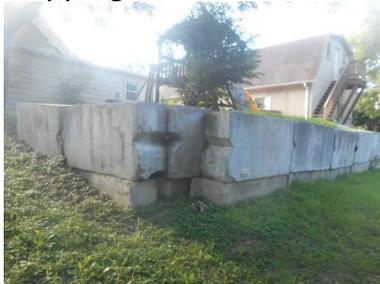
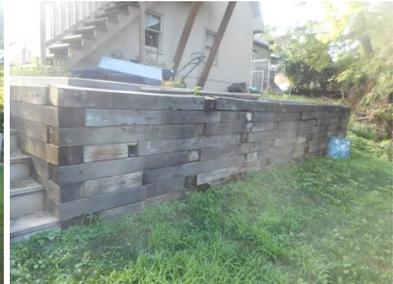
7. Window Wells: Metal
8. Foundation Grading:
9. Retaining Walls: Concrete, Railroad ties: Retaining walls have some settlement. Walls appear stable.
Railroad ties wall has some tipping / deterioration.

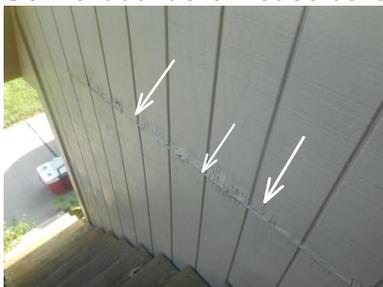
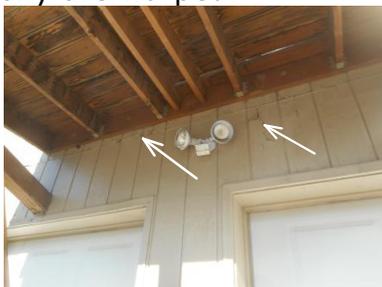
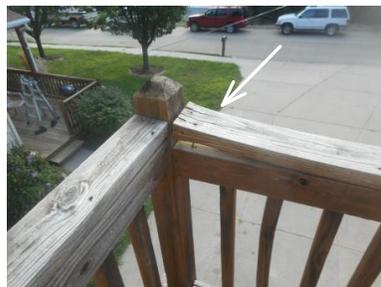
- 1. Type of Structure: Attached Car Spaces: 4 car
- 2. Garage Door: Two, Metal
- 3. Door Opener: Two
- 4. Exterior: Same age/type as house: Siding on garage has deterioration where panels meet west side and under deck at front.
Siding has some less significant weathering / deterioration in other areas.
Screens missing at garage windows. Some windows are stuck. Trim at window exterior warped / loose.
Some boards on east balcony are warped.

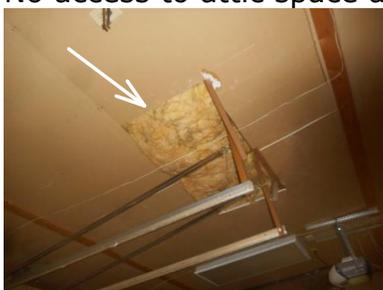
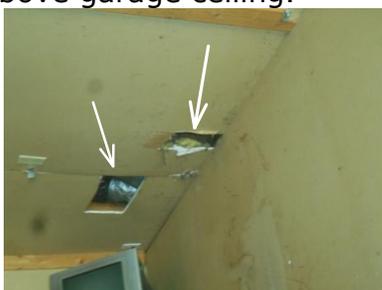
- 5. Service Doors:
- 6. Walls / Ceiling: There are holes in garage ceiling. Recommend sealing these if upper level is going to be used for sleeping.
No access to attic space above garage ceiling.

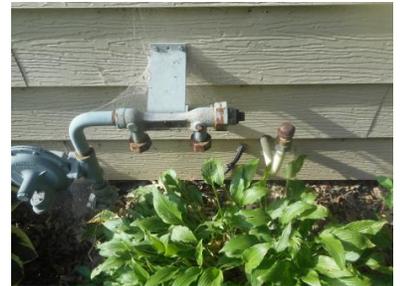
1. Service Line: Copper
2. Main Water Shutoff: Basement
3. Water Lines: Copper and pex
4. Drain / Vent Pipes: PVC
5. Floor Drain: Water ponding on floor by floor drain from air conditioner. Floor drain is either capped or clogged. Recommend a licensed plumber install a condensate pump box to drain line for air conditioner condensate.
6. Gas Meter: Exterior: Gas line is disconnected at meter.

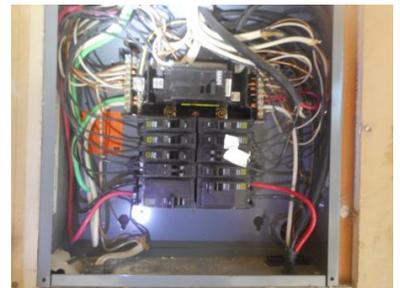
- 8. Panel Rating: 100 Amps
- 9. Main Breaker Size: 100 Amps
- 10. Service Wires: Copper
- 11. Breakers: 3 oversized 120 volt breakers at right bus bar in panel.
- 12. Ground Ground and neutral wires connected together on the same bus bar. Ground and neutral wires are supposed to be kept isolated from each other in sub panels.
- 13. Is the panel bonded? Yes No

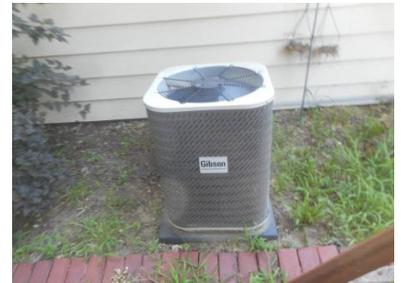
1. Temperature Differential: 66-49=17 degrees
2. Manufacturer: Gibson
3. Age: 8 to 11 years
4. Type: Central A/C Capacity: 3 Ton
5. General Condition:
6. Exterior Unit: Maintenance: Exterior unit is dirty. Suggest rinsing with garden hose.
7. Interior Components:
8. Freon Lines:
