Home Inspection

Grant
7142 21st Street
Omaha, NE 68048

Property Information

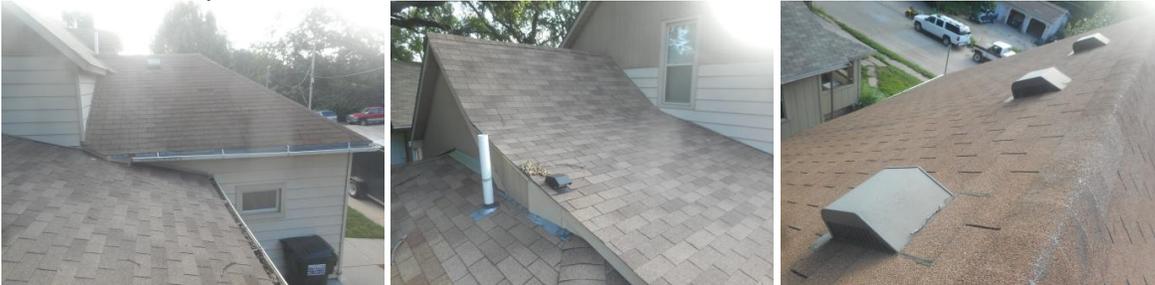
Main Roof Surface

4. Roof Covering: 3 tab asphalt shingle: Shingles at south facing roof and lower south roof have significant granular loss. Some shingles in this area have been replaced. There is a missing shingle tab at south facing roof. A couple missing shingle tabs at west facing roof.

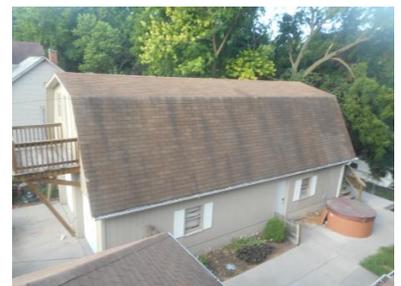
Garage Roof Surface

8. Roof Type: Gambrel
9. Approximate Age: 14 to 17 years
10. Roof Covering: 3 tab asphalt shingle: Shingles at south facing roof and lower south roof have significant granular loss. Some shingles in this area have been replaced.

11. Number of Layers:
12. Roof Slope: Steep, Medium: Some sag / dishing noted at north upper roof and roof on back addition.
13. Flashing:
14. Gutters/Downspouts: Metal: Gutters are clogged and need cleaning. Clogged gutters increase the risk of basement flooding.
15. Valleys: Metal
16. Ventilation: Roof and soffit vents
17. Plumbing Vents:

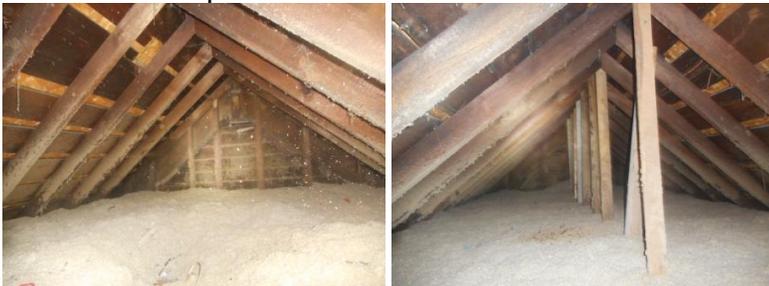
Main Attic

2. Attic Access: Upper hall ceiling.
3. Roof Framing: Rafters on 16 inch centers

- 4. Roof Sheathing: Boards, OSB (Oriented Strand Board)
- 5. Insulation: Batt and loose blown cellulose
- 6. Insulation Depth: 8 to 10 inches

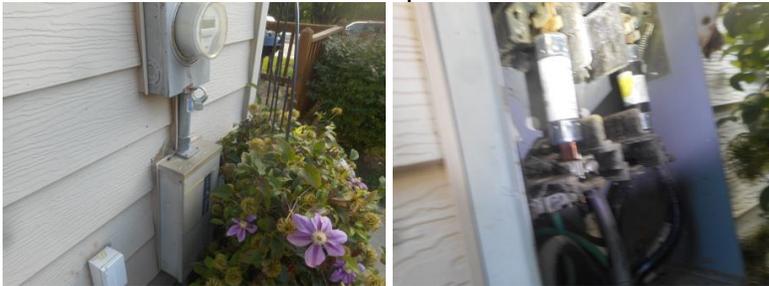
Basement Electric Panel

- 1. Manufacturer: Square D
- 2. Panel Rating: 200 Amps
- 3. Main Breaker Size: 200 Amps: Main breaker is in box at exterior under meter.

- 4. Service Wires: Copper
- 5. Breakers:
- 6. Is the panel bonded? Yes No
